Bulletin No.: PIT5809A
Published date: 04/23/2021

PIT5809A Clunk Pop Rattle Knock Click Type Noise Heard or Felt In The Steering

Models

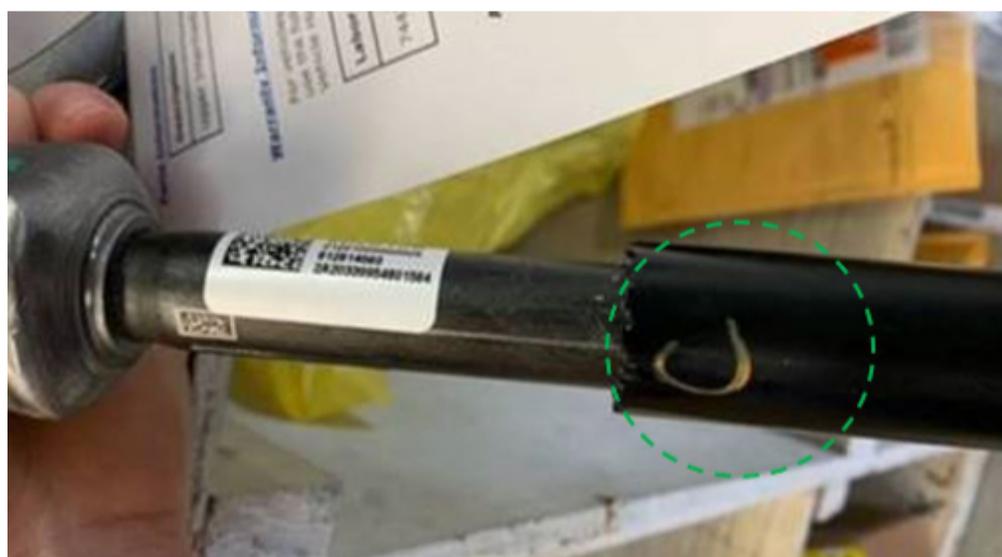
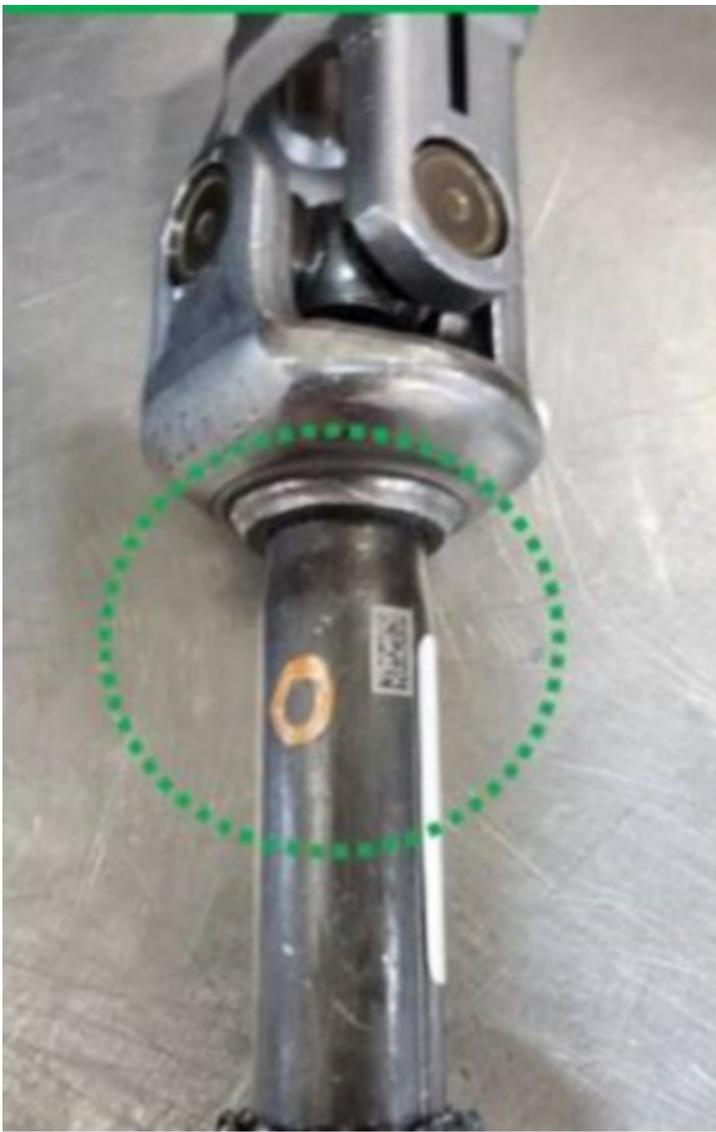
Involved Region or Country	North America
Condition	Some customers may comment on a clunk, pop, rattle, or knock type noise that can be heard or felt in the steering column. This concern may be more noticeable when turning at low speeds on rough road surfaces.
Cause	This concern could be caused by the steering column upper Intermediate shaft.

To correct this concern, replace the steering column upper Intermediate shaft with part number 84488136. Currently, this part number is still the old part number and a new part number will be released soon. To ensure you are getting the new updated Intermediate shaft, make sure it has one of the paint marks shown below. If the new intermediate shaft does not have one of the paint marks shown below, then it is not the updated version.
